1. Troubleshooting Procedures

2. Troubleshooting Situations

OC2 TRIP CASE

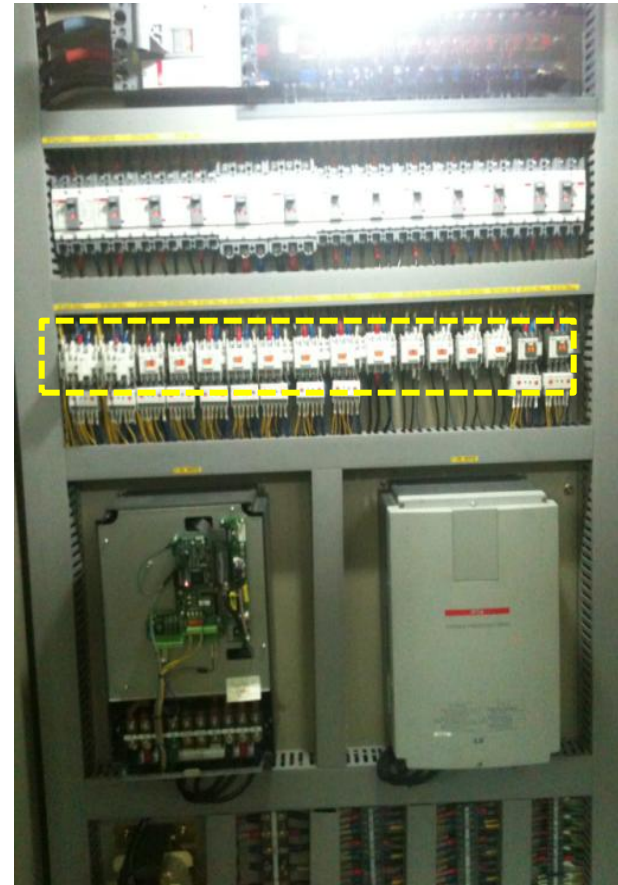
Picture

Model	SV300IP5A-4
Problem	<ul style="list-style-type: none">• OC2 Trip occurs occasionally.- Check TRIP history of OC2 (OC2, 60.0Hz,50A,STD 5 times).• Trip occurs about twice a day.
Cause	<ul style="list-style-type: none">• It is estimated that this trip is an abnormal operation occurring due to panel M/C open-close noise (12 units of DOL System is included inside panel).
Resolution	<ul style="list-style-type: none">• Change carrier frequency to take proper measures for noise (2 → 0.7kHz).
Tip	<ul style="list-style-type: none">• In case of malfunction resulting from M/C Noise, it is recommended to use M/C equipped with noise filter.

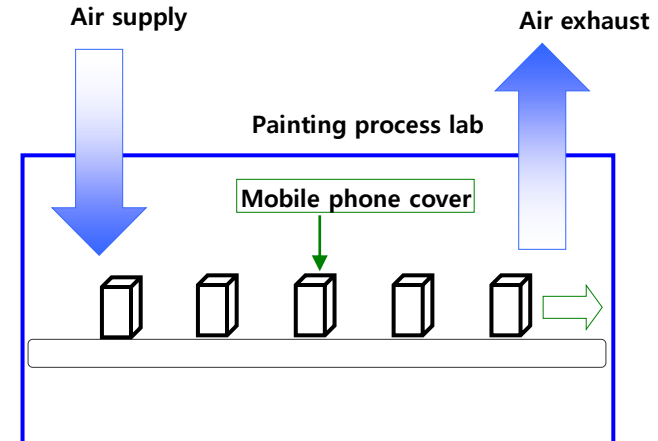
System

Model	SV185IP5A-4
Load	FAN
Problem	<ul style="list-style-type: none"> • OC2 TRIP occurs occasionally. • TRIP LIST <ul style="list-style-type: none"> - OC2, 3.17Hz, 48.6A, ACC - OC2, 25.02Hz, 51.9A, ACC - OC2, 24.40Hz, 52.4A, ACC
Cause	<ul style="list-style-type: none"> • Temperature in panel is high, and temperature level is about 60°C in terms of inverter parameters. It is estimated that this trip is a malfunction due to degraded part characteristics depending on temperature variation. • Carrier frequency 5.0KHz => Ca. 58~61°C • Carrier frequency 1.0KHz => Ca. 48~51°C • Among parameters, V/F pattern is SQUARE. Thus, many cases of IOLT TRIP occur due to load current during acceleration.
Resolution	<ul style="list-style-type: none"> • Change parameter. <ul style="list-style-type: none"> - ACC: 500SEC=>50SEC - DEC: 600SEC=>50SEC - V/F pattern: SQUARE → V/F - Carrier Frequency: 5KHz → 1KHz
Tip	<ul style="list-style-type: none"> • OC2 may work out of order due to temperature gap of IGBT depending on temperature gap of heat sink (Cooling fan failure, etc)
